Bezares Group

# **REAL IMAGES OF COMMON FAILURES**

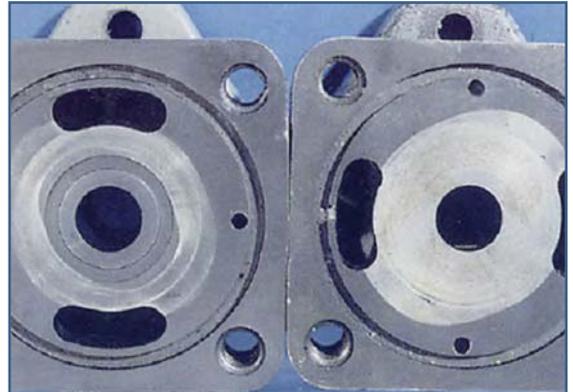
### SURFACE SCORING

This pump body surface is phosphate coated. It can be scored from pump seizure or severe contamination trapped between the rotor and body surface. The pump body on the left shows typical scoring. Such scored bodies can undergo minor resurfacing (.005" to .010"), but must be retreated (phosphated) before being returned to service. If major resurfacing is performed (.010" to .020" maximum), the O-ring groove must be deepened by an equal amount.

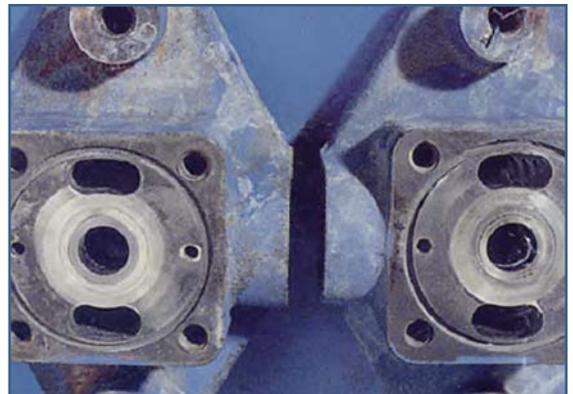
### RESURFACING REQUIREMENTS

The body on the left (refer to photo to right) is scored badly enough to require resurfacing. The pump body surface on the right, however, has no depth of scoring—only the treatment colour has worn off. Bodies in this condition can be used "as is".

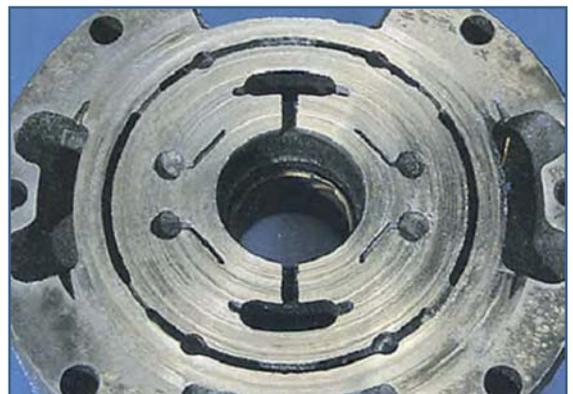
### INLET SUPPORT PLATES DAMAGES BY AERATION

The effects of aeration are similar on both inlet and outlet support plates. Here we see obvious damage caused by collapsed air bubbles. The plate surface is also badly scored. It can be resurfaced up to .010" without renotching or deepening the grooves. Resurfacing between .010" and .020" will require re-machining the groove depth and metering notches correspondingly. The resurfaced plates must be phosphate coated.

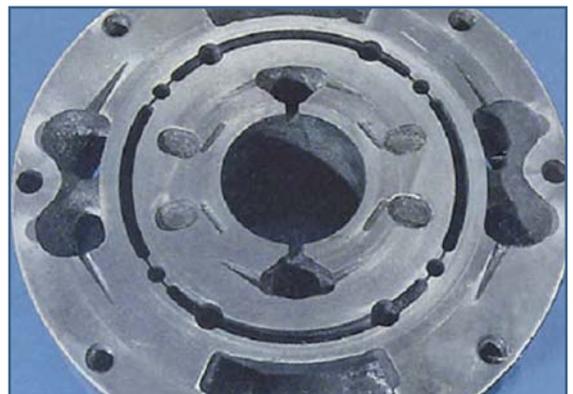
### NO SIGNIFICANT DAMAGE

This outlet support plate shows no significant wear. After stoning to remove burrs, it can be reused.

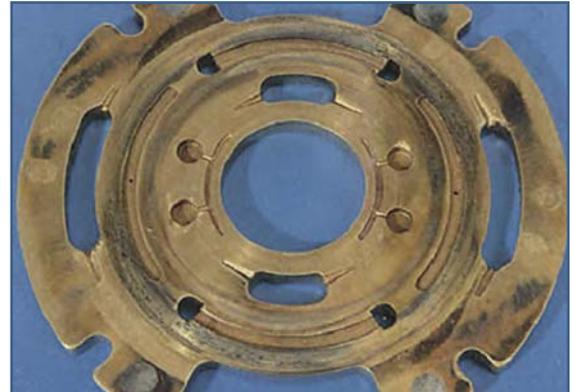
### NORMAL DISCOLORATION

This flex plate displays a typical amount of discoloration. The discoloration alone should have no effect on pump operation.

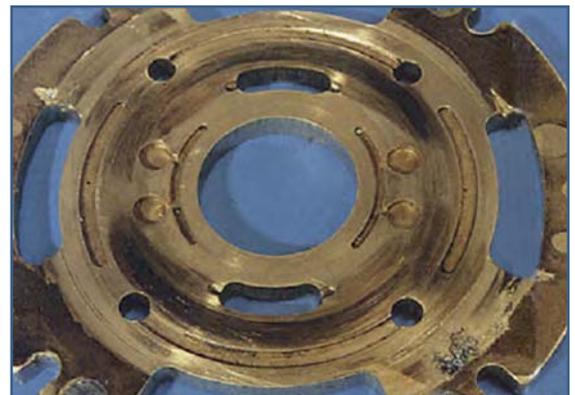
### SEVERE AERATION DAMAGE

The erosion on the VQ flex plate was caused by collapsed air bubbles (aeration) near the outlet port metering notches. If the damage isn't too severe, the plate can be resurfaced to a maximum .005". The flex plate to the right is damaged beyond repair.

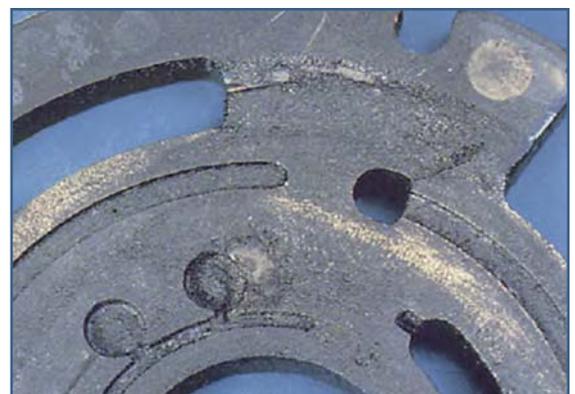
### DARKENING AND EROSION

Damage as shown here is the result of excessive system temperature. After this problem in the system has been corrected, the entire cartridge must be replaced.

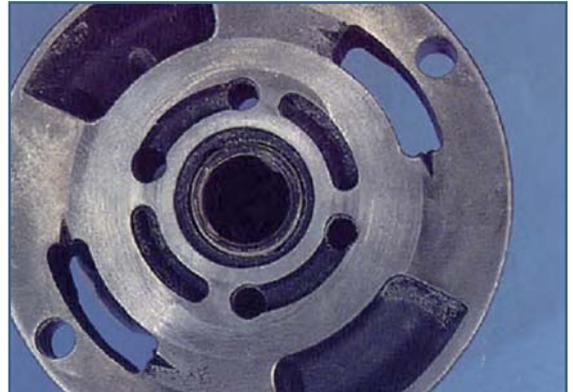
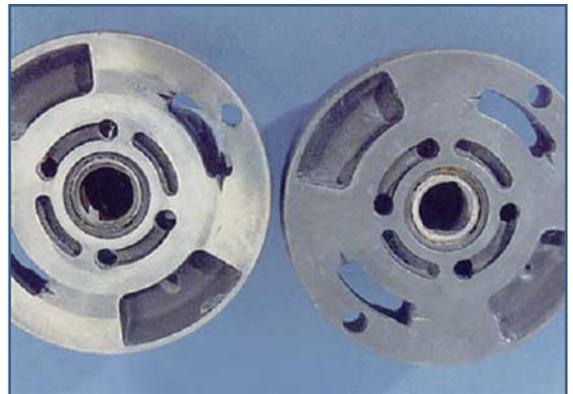
### SIGNS OF PUMP AERATION

Because air is compressible, any bubbles trapped between the vanes of a pump are violently imploded when subjected to outlet pressure. If an imploded air bubble is near a pump surface, the energy released can remove material. This leaves cavitation-type pock marks (as seen here at the outlet metering notches). The particles of metal blasted away become fine contamination that can cause wear and scoring of the pressure plate and mating rotor failure. Pumps surfaces with mild aeration and cavitation marks can be resurfaced up to .010". If more than .010" is removed during resurfacing, the metering notches must be renotched by the same amount. Any bearing or guide surfaces that are ground should always be lapped or polished to improve surface texture. After resurfacing, a phosphate coating must be applied.

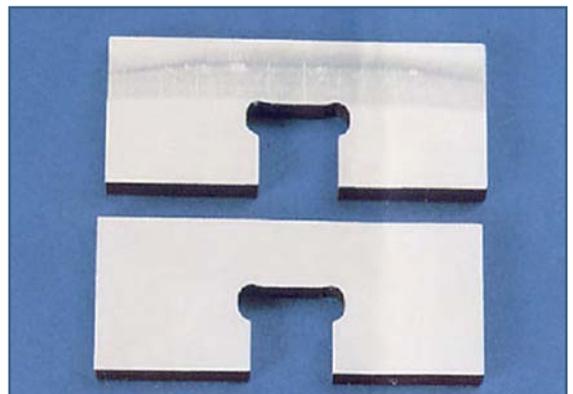
### VANE FROSTING

Compare the appearance of the vane (bottom) with the frosted look of a vane that's been subjected to fluid contamination (top). The cartridge this vane came from must be replaced.

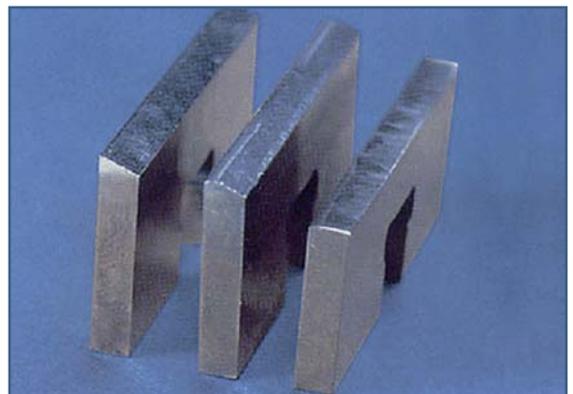
### TIP WEAR

The vane on the left is new. The vane in the middle is worn down from the fluid contamination. The extreme wear seen on the vane to the right was caused by aeration. Similar damage can also be caused by fluid in poor or marginal condition. The associated cartridge must be replaced.

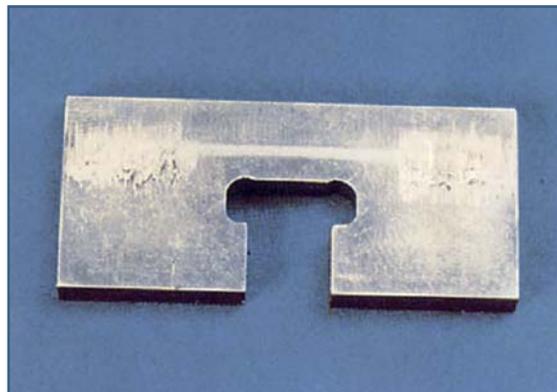
### GALLED VANE

This type of galling damage is symptomatic of over-pressure or over-temperature. This indicates a cartridge damaged beyond repair.

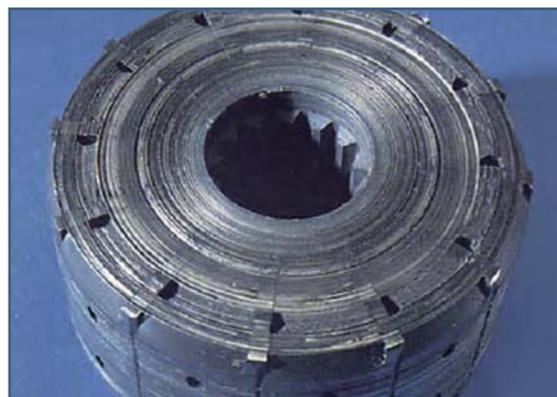
### TYPICAL SEIZURE DAMAGE

Seizure type failures can be due to fluid contamination, dry run, lack of lubricity in the fluid, high system temperature, or improper clearance between cam ring and rotor thicknesses. Rotors with vane slots worn more than .0002" cannot be reused. Rotors with scored surface like the one shown here cannot be reworked and must be replaced.

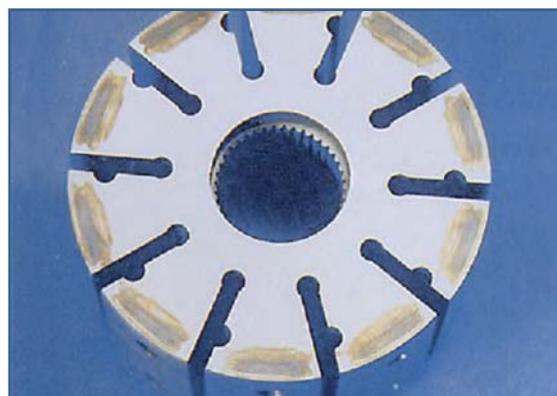
### ROTOR SMEAR

Rotor surfaces can be badly scored by contamination and/or seizure. Vane slots can also become worn or scored by fluid contamination.

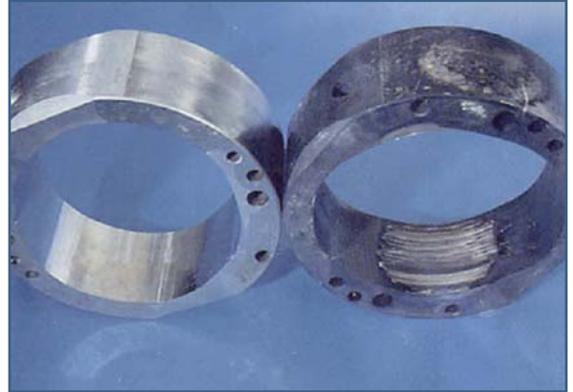
### COMPARISON OF TWO FAILED CAM RINGS

The ring on the left has mild rippling and can be used again. The one on the right, however, has decomposed badly from extreme heat and shows evidence of pump seizure. It must be replaced.

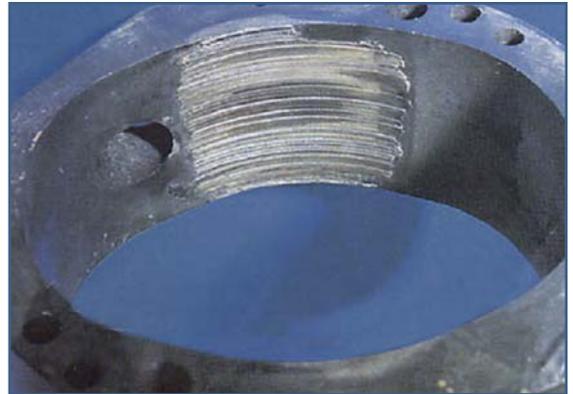
### SEIZURE DAMAGE

Pump seizures (as evidenced by galling or metal transfer) can make local temperatures rise dramatically. These high temperatures cause discoloration of the cam ring, as seen here. The local temperature was so high that the vane tips literally fused into the ring contour. A ring in this condition cannot, and should not, be reworked).

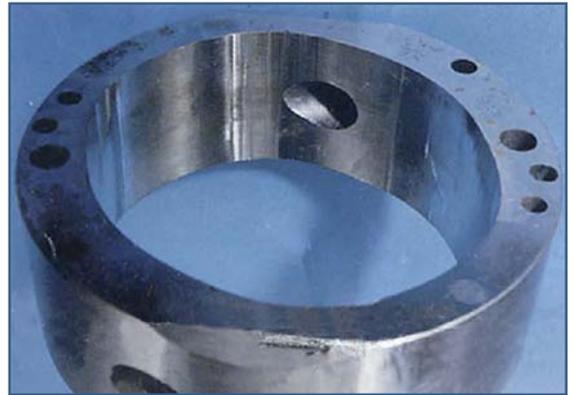
### RIPPLE MARKS

Vane pump cam ring will have a shiny inner surface due to normal operation. Some rings (as seen here) may also exhibit ripples marks caused by cavitation, aeration or contamination. These marks can vary from minor to severe. Mild ripples can be polished out and the ring reused. Always polish the cam ring in the indicated direction of rotation. Heavy rippling requires expert examination to determine whether geometrical grinding can be used to salvage the ring. Nital etching should also be performed to ensure that the surface is not softened.

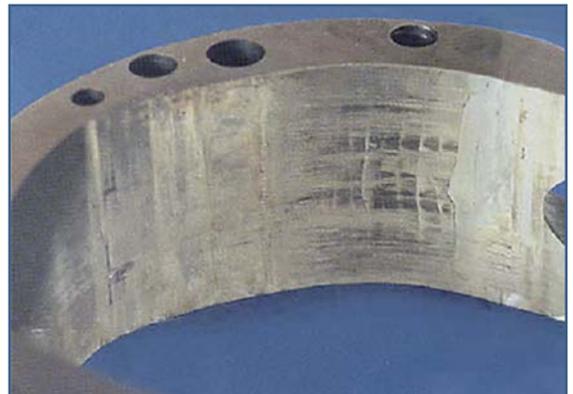
### HEAT CHECKED SURFACE

This appearance indicates one or more system problems including excessive temperature, marginal fluid quality or an aerated inlet. Heat checked cam rings must be replaced.

Cam rings can crack or break completely at their weakest cross sectional point. This type of failure is caused by pressure surges beyond the pump's design specification.

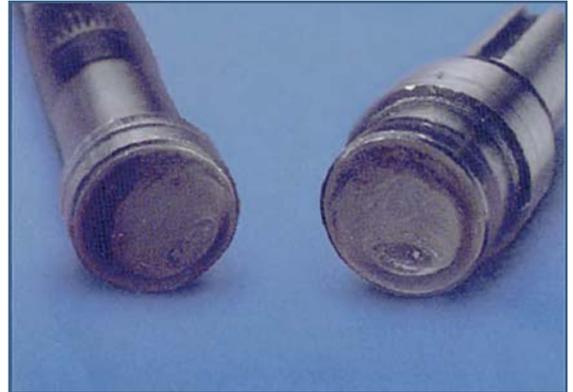
### ROTATIONAL BENDING FATIGUE

Pump shaft failures are generally caused by repeated stress. Like a chain that is only as strong as its weakest link, shaft damage will occur when the stresses encountered at the weakest link, shaft damage will occur when the stresses encountered at the weakest point of the shaft finally exceeds its strength.

The shaft above broke cleanly at a 90 angle to its axis of rotation.

This type of failure is due to rotational bending fatigue. A likely cause is misalignment between the pump and its "prime mover" that makes the shaft flex slightly with each revolution. Fractures like this usually start in some area of concentrated stress that is at least partially perpendicular to the shaft axis. These weak points in the shaft can include grooves, fillets, and holes. The shaft shown here has the ripple marks typically found with rotational bending fatigue failures. These marks indicate that the shaft was unevenly loaded or unbalanced. The smoother area near the edge is where the fracture started. The curved ripples get gradually courser, with a rough, shell-like spot where the shaft finally ruptured.

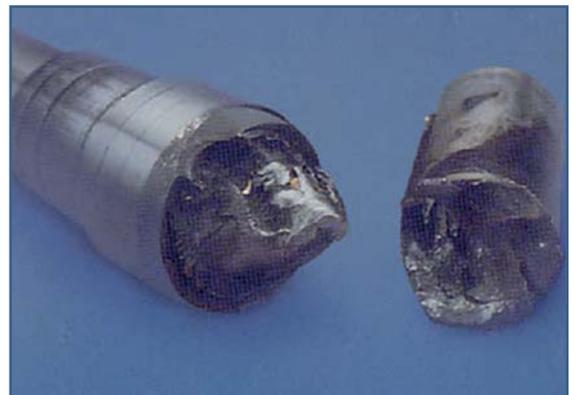
### TORSIONAL FATIGUE

Seizure type failures can be due to fluid contamination, dry run, lack of lubricity in the fluid, high system temperature, or improper clearance between cam ring and rotor thicknesses. Rotors with vane slots worn more than .0002" cannot be reused. Rotors with scored surface like the one shown here cannot be reworked and must be replaced.
