SQUARE PUMP BODY

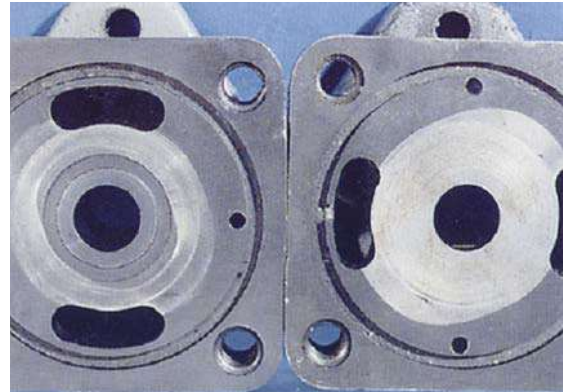
SURFACE SCORING

This pump body surface is phosphate coated. It can be scored from pump seizure or severe contamination trapped between the rotor and body surface. The pump body on the left shows typical scoring. Such scored bodies can undergo minor resurfacing (.005" to .010"), but must be retreated (phosphated) before being returned to service. If major resurfacing is performed (.010" to .020" maximum), the O-ring groove must be deepened by an equal amount.

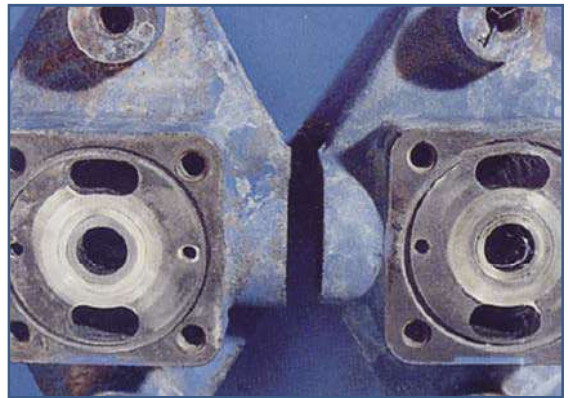
RESURFACING REQUIREMENTS

The body on the left (refer to photo to right) is scored badly enough to require resurfacing. The pump body surface on the right, however, has no depth of scoring—only the treatment colour has worn off. Bodies in this condition can be used "as is".

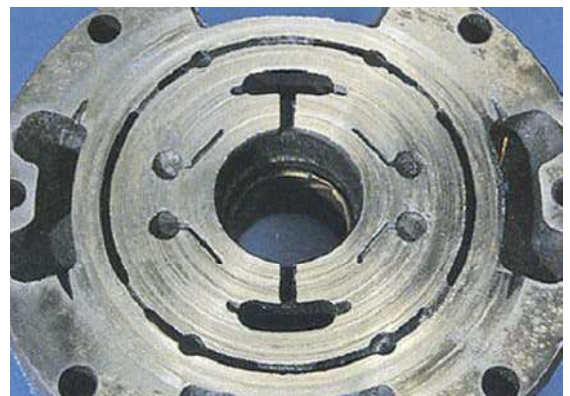
INLET SUPPORT PLATES DAMAGES BY AERATION

The effects of aeration are similar on both inlet and outlet support plates. Here we see obvious damage caused by collapsed air bubbles. The plate surface is also badly scored. It can be resurfaced up to .010" without renotching or deepening the grooves. Resurfacing between .010" and .020" will require re-machining the groove depth and metering notches correspondingly. The resurfaced plates must be phosphate coated.

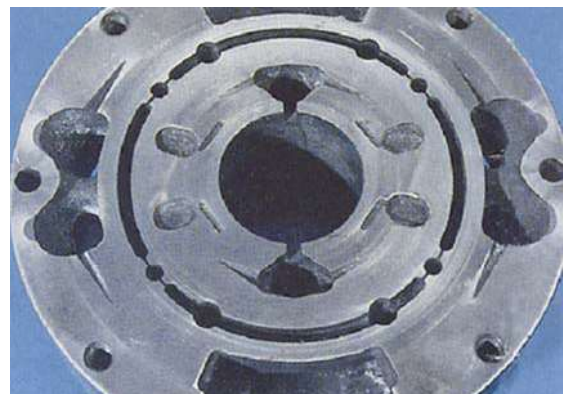
NO SIGNIFICANT DAMAGE

This outlet support plate shows no significant wear. After stoning to remove burrs, it can be reused.

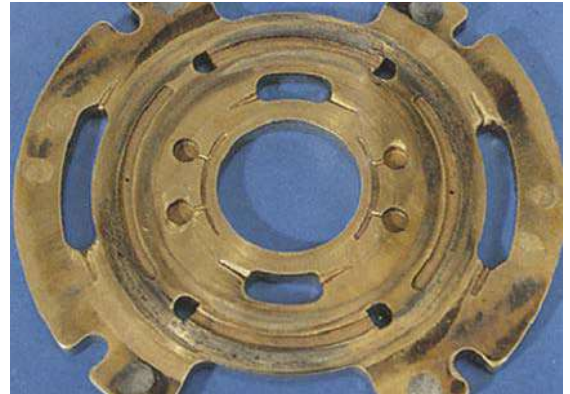
NORMAL DISCOLORATION

This flex plate displays a typical amount of discoloration. The discoloration alone should have no effect on pump operation.

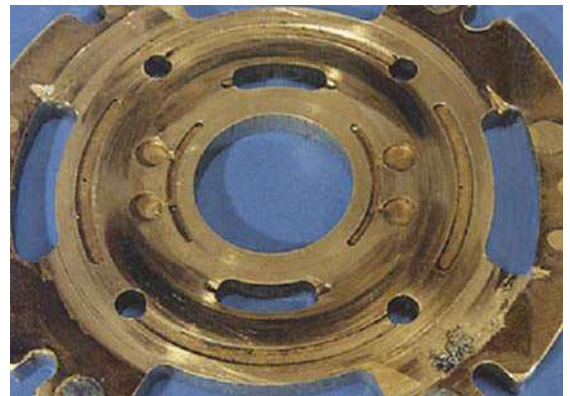
SEVERE AERATION DAMAGE

The erosion on the VQ flex plate was caused by collapsed air bubbles (aeration) near the outlet port metering notches. If the damage isn't too severe, the plate can be resurfaced to a maximum .005". The flex plate to the right is damaged beyond repair.

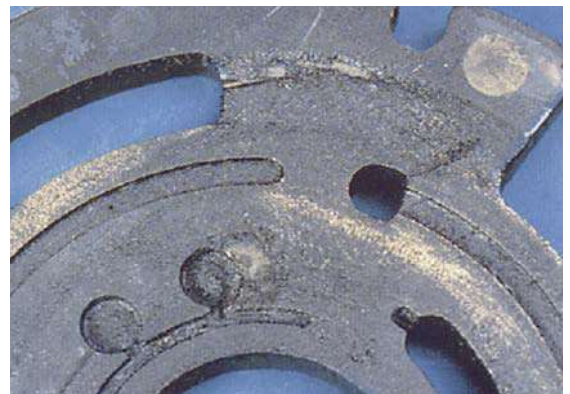
DARKENING AND EROSION

Damage as shown here is the result of excessive system temperature. After this problem in the system has been corrected, the entire cartridge must be replaced.

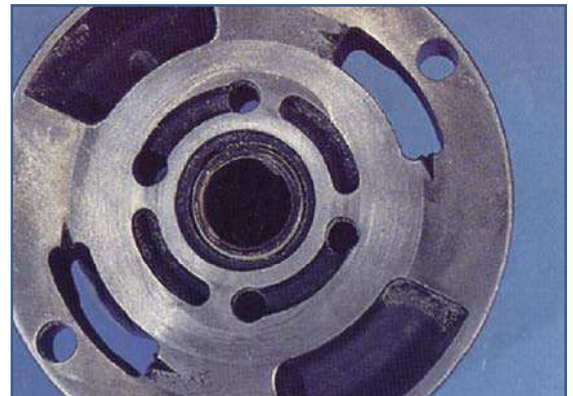
SIGNS OF PUMP AERATION

Because air is compressible, any bubbles trapped between the vanes of a pump are violently imploded when subjected to outlet pressure. If an imploded air bubble is near a pump surface, the energy released can remove material. This leaves cavitation-type pock marks (as seen here at the outlet metering notches). The particles of metal blasted away become fine contamination that can cause wear and scoring of the pressure plate and mating rotor failure. Pumps surfaces with mild aeration and cavitation marks can be resurfaced up to .010". If more than .010" is removed during resurfacing, the metering notches must be renotched by the same amount. Any bearing or guide surfaces that are ground should always be lapped or polished to improve surface texture. After resurfacing, a phosphate coating must be applied.

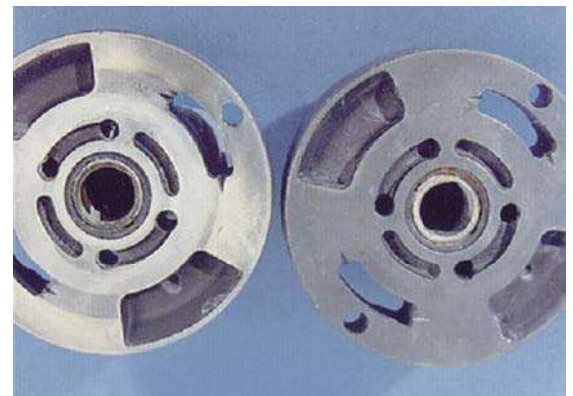
SEVERE AERATION DAMAGE

The pressure plate on the left has suffered severe damage from aeration and is beyond repair. Resurfacing would fail to restore the material that's been chipped away near the metering notches. (The plate on the right is in good condition and is shown for comparison).

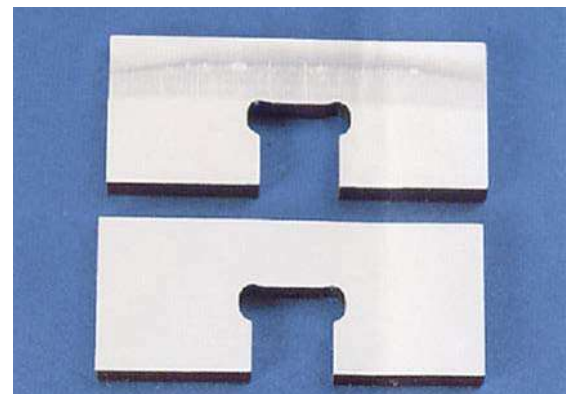
VANE FROSTING

Compare the appearance of the vane (bottom) with the frosted look of a vane that's been subjected to fluid contamination (top). The cartridge this vane came from must be replaced.

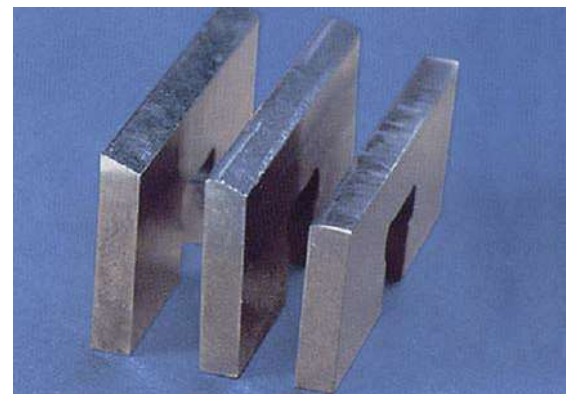
TIP WEAR

The vane on the left is new. The vane in the middle is worn down from the fluid contamination. The extreme wear seen on the vane to the right was caused by aeration. Similar damage can also be caused by fluid in poor or marginal condition. The associated cartridge must be replaced.

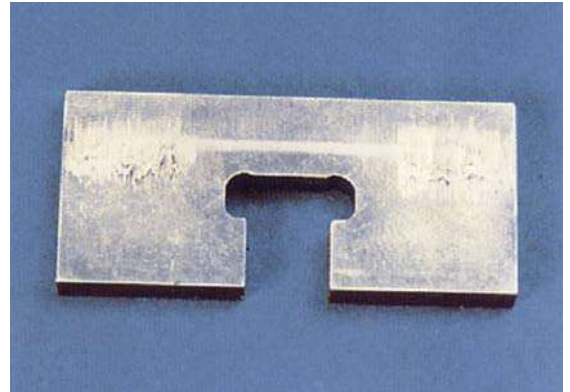
GALLED VANE

This type of galling damage is symptomatic of over-pressure or over-temperature. This indicates a cartridge damaged beyond repair.

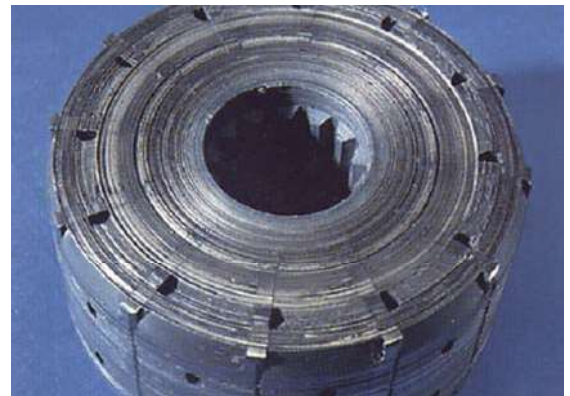
TYPICAL SEIZURE DAMAGE

Seizure type failures can be due to fluid contamination, dry run, lack of lubricity in the fluid, high system temperature, or improper clearance between cam ring and rotor thicknesses. Rotors with vane slots worn more than .0002" cannot be reused. Rotors with scored surface like the one shown here cannot be reworked and must be replaced.

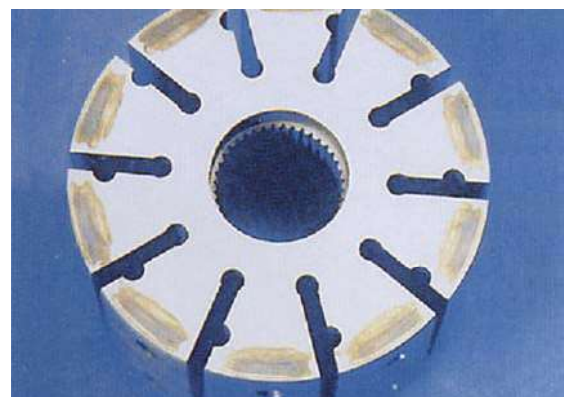
ROTOR SMEAR

Rotor surfaces can be badly scored by contamination and/or seizure. Vane slots can also become worn or scored by fluid contamination.

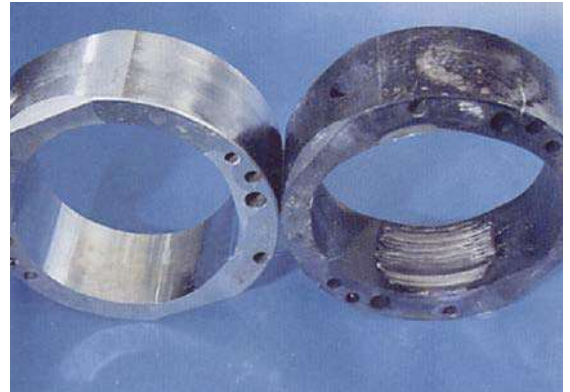
COMPARISON OF TWO FAILED CAM RINGS

The ring on the left has mild rippling and can be used again. The one on the right, however, has decomposed badly from extreme heat and shows evidence of pump seizure. It must be replaced.

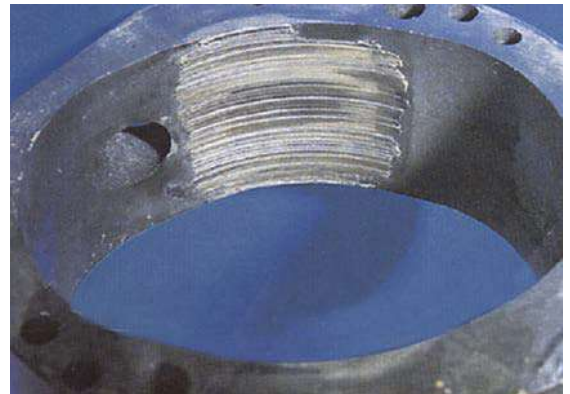
SEIZURE DAMAGE

Pump seizures (as evidenced by galling or metal transfer) can make local temperatures rise dramatically. These high temperatures cause discoloration of the cam ring, as seen here. The local temperature was so high that the vane tips literally fused into the ring contour. A ring in this condition cannot, and should not, be reworked).

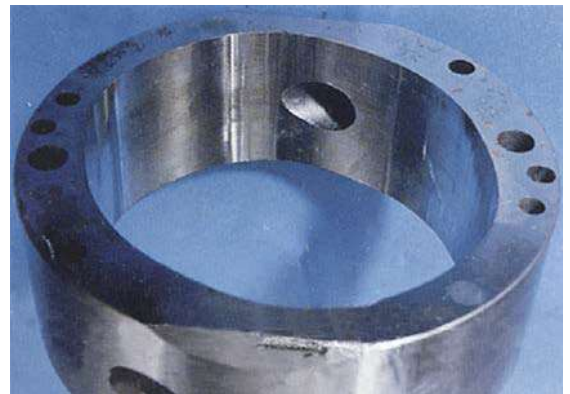
RIPPLE MARKS

Vane pump cam ring will have a shiny inner surface due to normal operation. Some rings (as seen here) may also exhibit ripples marks caused by cavitation, aeration or contamination. These marks can vary from minor to severe. Mild ripples can be polished out and the ring reused. Always polish the cam ring in the indicated direction of rotation. Heavy rippling requires expert examination to determine whether geometrical grinding can be used to salvage the ring. Nital etching should also be performed to ensure that the surface is not softened.

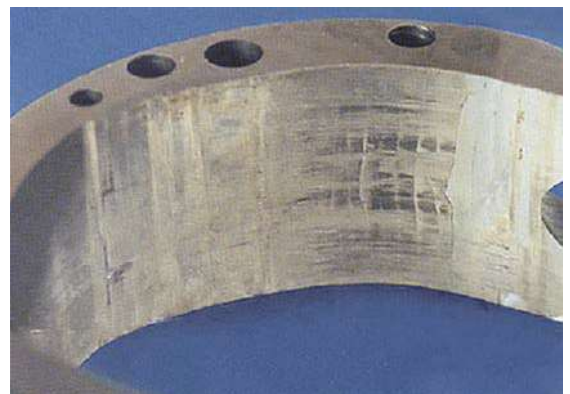
HEAT CHECKED SURFACE

This appearance indicates one or more system problems including excessive temperature, marginal fluid quality or an aerated inlet. Heat checked cam rings must be replaced.

Cam rings can crack or break completely at their weakest cross sectional point. This type of failure is caused by pressure surges beyond the pump's design specification.

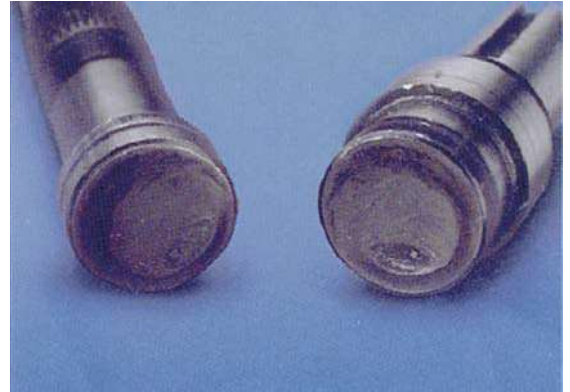
ROTATIONAL BENDING FATIGUE

The shaft above broke cleanly at a 90 angle to its axis of rotation.

This type of failure is due to rotational bending fatigue. A likely cause is misalignment between the pump and its "prime mover" that makes the shaft flex slightly with each revolution. Fractures like this usually start in some area of concentrated stress that is at least partially perpendicular to the shaft axis. These weak points in the shaft can include grooves, fillets, and holes. The shaft shown here has the ripple marks typically found with rotational bending fatigue failures. These marks indicate that the shaft was unevenly loaded or unbalanced. The smoother area near the edge is where the fracture started. The curved ripples get gradually courser, with a rough, shell-like spot where the shaft finally ruptured.

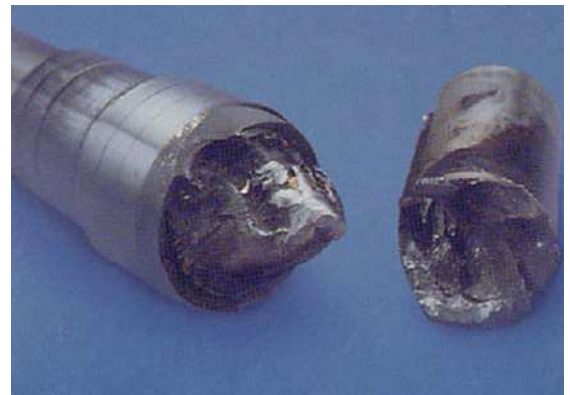
TORSIONAL FATIGUE
